RE: **Unitarian Universalist Congregation of Atlanta**
ECS Job # **10:11013**
Permits:
Location: **2650 North Druid Hills Rd
Atlanta, GA 30329**

FIELD REPORT

Project **Unitarian Universalist Congregation of Atlanta**
 Location **Atlanta, GA**
 Client **Unitarian Universalist Congregation of Atlanta**
 Contractor **None Listed**

Project No. **10:11013**
 Report No. **29**
 Day & Date **Wednesday 12/22/2021**
 Weather **50 °/ clear**
 On-Site Time **1.50**
 Lab Time **0.25**
 Travel Time* **1.25**
 Total **3.00**
 Re Obs Time **0.00**

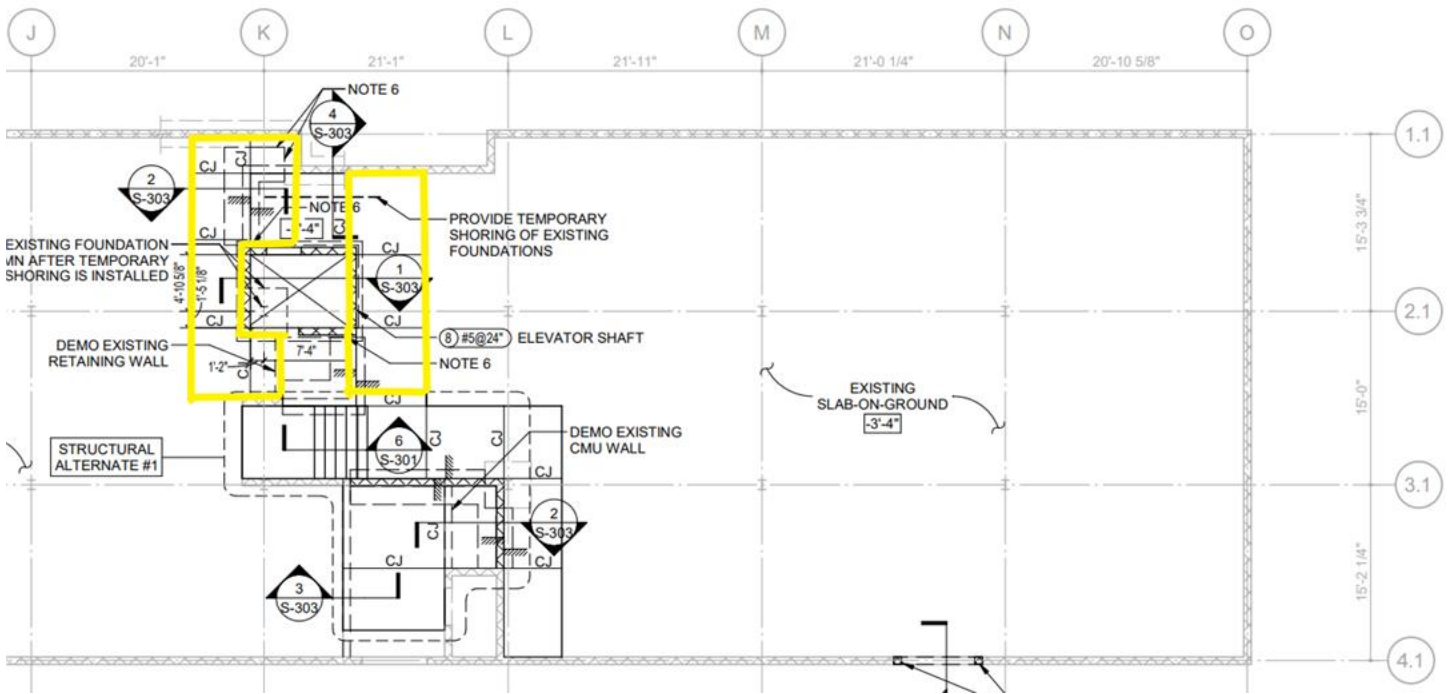
Figure 1

1. Observe the subgrade for the slab between column lines J.5/K.7 and 1.1/2.6. Please see the attached sketch to see the exact location.

The subgrade shallow depth was visually observed and manually probed with a 3/8 diameter probe rod. The subgrade appeared to be firm with no soft areas observed.

Subgrade for slab

Subgrade conditions should remain dry and free of loose soils/debris prior to GAB placement. If exposed to inclement weather, the subgrade should be re-observed by ECS.
