RE: **Unitarian Universalist Congregation of Atlanta**
ECS Job # **10:11013**
Permits:
Location: **2650 North Druid Hills Rd
Atlanta, GA 30329**

FIELD REPORT

Project No. **10:11013**
 Report No. **39**
 Day & Date **Friday 1/21/2022**
 Weather **35 °/ Cloudy**
 On-Site Time **0.50**
 Lab Time **0.25**
 Travel Time* **1.00**
 Total **1.75**
 Re Obs Time **0.00**

NPDES SITE INSPECTION REPORT

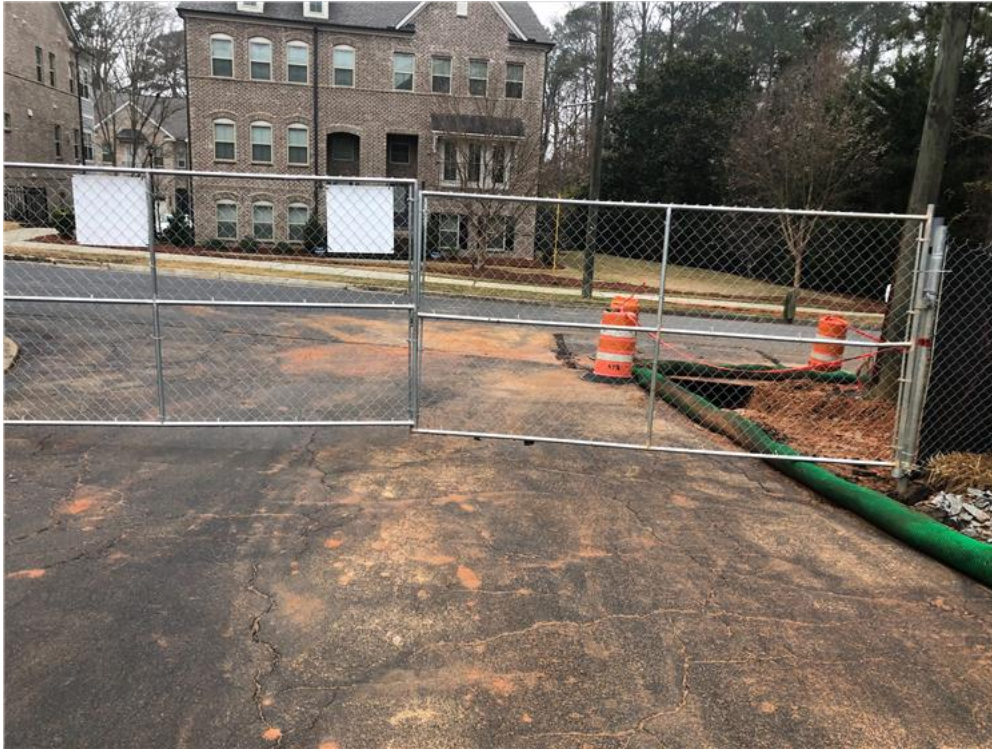
Figure 1

5	Is there evidence of sediment being tracked into the street?	<input checked="" type="checkbox"/> Yes <input type="checkbox"/> No	<input checked="" type="checkbox"/> Yes <input type="checkbox"/> No	Sediment is being tracked into public right-of-ways (high Haven Ct NE). Conduct regular sweeping at entrances/exits to keep sediment from being tracked out into the street.

Sediment tracking onto public right-of way

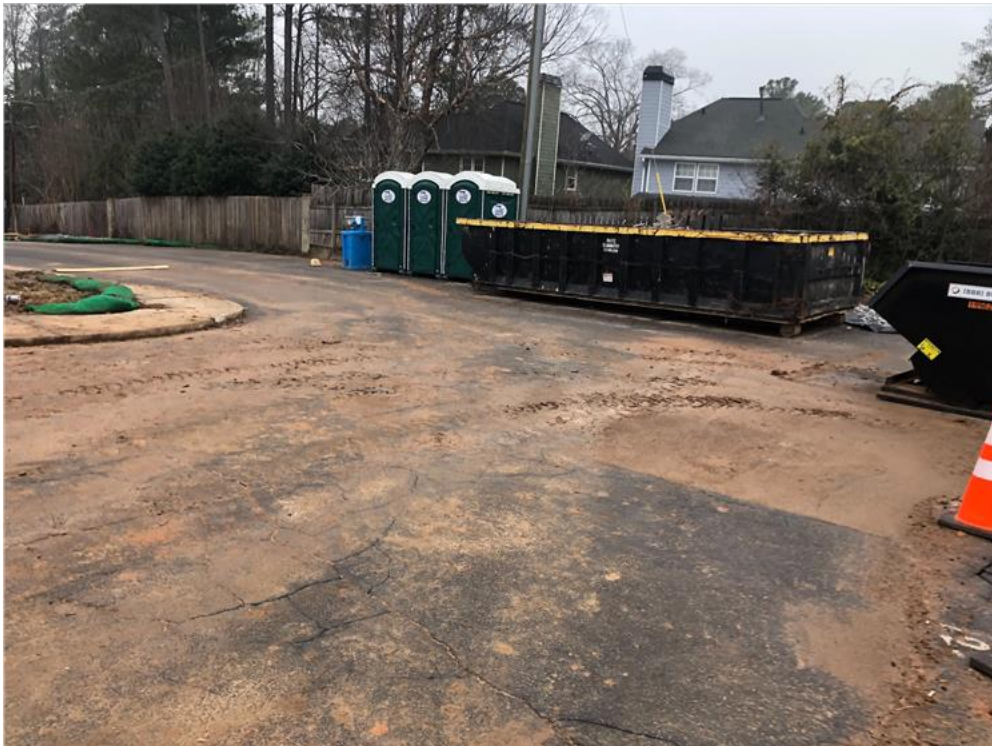
Figure 2

Sediment tracking onto the parking lot
