STORMWATER CORRECTIVE ACTION PLAN

ORIGINAL PLAN 2/14/22

UPDATE 2/17/22

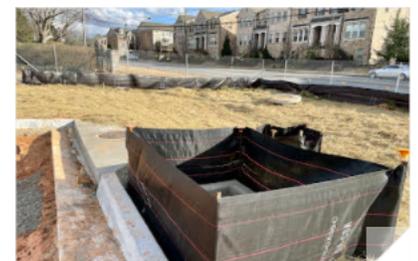
UPDATE 2/17: Additional concrete curbing, silt fence, straw and grass seed were installed to protect this area.

- c) Area 3 Base of the new parking lot utility holes and swale
 - i) The team observed Sediment in the water vault. Project Phoenix asks the contractor to protect the vault with silt fencing, straw bales, or other Best Management Practices as determined by the contractor to prevent sediment from entering the openings of utility holes.

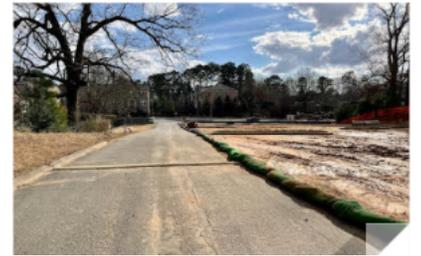
UPDATE 2/17/22: [Silt fence and compost bags installed along the full length of the driveway.](#)

- e) Area 5 Main driveway to N. Druid Hills
 - i) The contractor should maintain curb bags or other Best Management Practices in this area to ensure no sediment runs off down the driveway to N. Druid Hill Road.
